**Flood Control Project Maintenance
Levee Inspections**

Fall 2019 Levee Maintenance Deficiency Summary Report

**Flood Control Project Maintenance
Levee Inspections****LMA District Cover Sheet****Fall 2019 Levee Inspection Results****Knights Landing Ridge Drainage District**

Knights Landing Ridge Drainage District

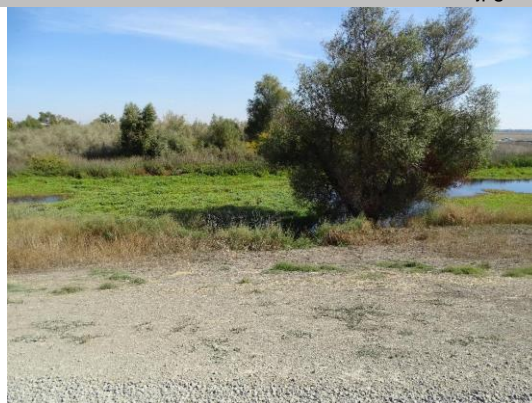
Photo 1 of 3 : UCIP_FA_2019_55381_81599.jpg

Comment Code					
Inspector Comment					
DS_ID:19360 FS_ID:55381 EP_NO: 9302 Repair Type: Non-Urgent Crossing Status: Found UCIP Comments: 10/08/2019 Concrete distribution box on LS toe has been removed. Slide gate with its metal stand debris should be removed from the channel as well. (O.Yakimov - DWR UCIP)12/07/2018 Need updated photos to show proper pipe abandonment. Update Part VI, 1. Pipe Section to remove part c and e. If crossing was abandoned properly crossing will need to be removed from the LMA responsibility list. (O. Magana - DWR UCIP)05/16/2016 Pipe has been grouted in place under permit 18987, 2015. (T. Hatch - DWR UCIP)04/05/2013 Pipe completely rusted through on LS slope of levee at toe/headwall of concrete distribution box. Pipe needs replacement or proper abandonment. Pipe not visible at outlet. (W. Wylie - DWR UCIP) FIELD_STRUCT_DESC: *ABANDONED* 36-inch corrugated metal drainage pipe through the levee, 27 feet below the crown. Slide gate on the waterside (WS) end. 12-foot by 6-foot concrete box on the landside (LS) end. (36-inch pipe [HLM 1.62] authorized under Automatic Board Order (ABO) issued as Permit No. 9302, 1974 - Barbara Lowe Elliott; 36-inch pipe abandoned by removing ends and pumping pipe full of concrete under Permit No. 18987, 2016 - Knaggs Ranch, LLC, care of John Brennan). [Additional Reference(s): DWR Levee Log, 1990. USACE Sacramento O&M Manual 127, June 1953, (Station 0+30)]. FS Date: 10/23/2019 2:41:37 PM

View of WS looking from crown

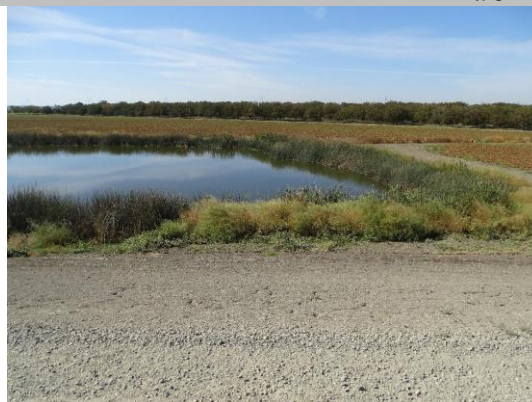
Photo 2 of 3 : UCIP_FA_2019_55381_81600.jpg

Concrete distribution box on LS toe

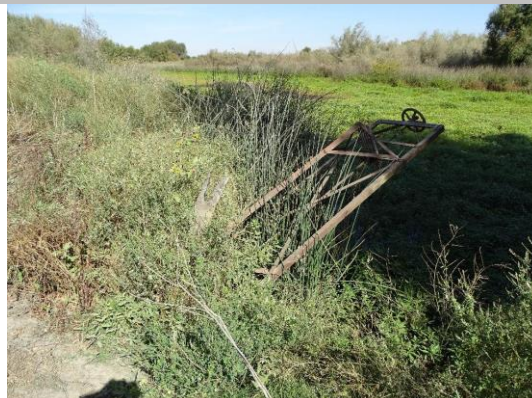
Photo 3 of 3 : UCIP_FA_2019_55381_81601.jpg

Comment Code						
Inspector Comment						
DS_ID:19360 FS_ID:55381 EP_NO: 9302 Repair Type: Non-Urgent Crossing Status: Found UCIP Comments: 10/08/2019 Concrete distribution box on LS toe has been removed. Slide gate with its metal stand debris should be removed from the channel as well. (O.Yakimov - DWR UCIP)12/07/2018 Need updated photos to show proper pipe abandonment. Update Part VI, 1. Pipe Section to remove part c and e. If crossing was abandoned properly crossing will need to be removed from the LMA responsibility list. (O. Magana - DWR UCIP)05/16/2016 Pipe has been grouted in place under permit 18987, 2015. (T. Hatch - DWR UCIP)04/05/2013 Pipe completely rusted through on LS slope of levee at toe/headwall of concrete distribution box. Pipe needs replacement or proper abandonment. Pipe not visible at outlet. (W. Wylie - DWR UCIP) FIELD_STRUCT_DESC: *ABANDONED* 36-inch corrugated metal drainage pipe through the levee, 27 feet below the crown. Slide gate on the waterside (WS) end. 12-foot by 6-foot concrete box on the landside (LS) end. (36-inch pipe [HLM 1.62] authorized under Automatic Board Order (ABO) issued as Permit No. 9302, 1974 - Barbara Lowe Elliott; 36-inch pipe abandoned by removing ends and pumping pipe full of concrete under Permit No. 18987, 2016 - Knaggs Ranch, LLC, care of John Brennan). [Additional Reference(s): DWR Levee Log, 1990. USACE Sacramento O&M Manual 127, June 1953, (Station 0+30)]. FS Date: 10/23/2019 2:41:37 PM

Slide gate on metal stand on WS toe needs removal

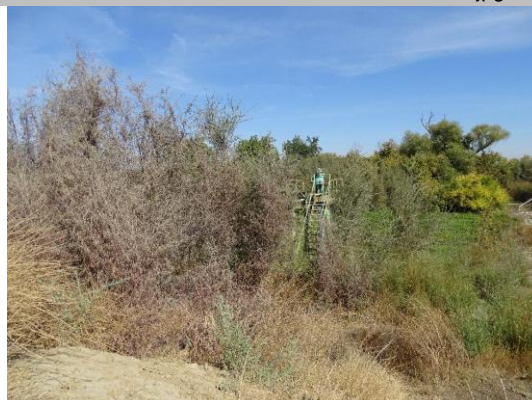
Photo 2 of 3 : UCIP_FA_2019_55685_82413.jpg

DS_ID:19361
 FS_ID:55685
 EP_NO: 9302
 Repair Type: Urgent
 Crossing Status: Found
 UCIP Comments: 10/08/2019 Record has been updated from Non-Urgent to Urgent, excavation into WS slope and around pipe noted in USACE PI and UCIP 2013 inspection. Unable to confirm in 2019 whether excavation is still present on the WS slope due to dense vegetation on the WS. (O.Yakimov - DWR UCIP)
 04/05/2013 Pipe exposed on WS slope in trench may need to be backfilled to prevent erosion under pipe. (W. Wylie - DWR UCIP)
 FIELD_STRUCT_DESC: 20-inch steel irrigation pipe through the levee, 8.8 feet below the crown. Pump on a steel pile structure at the waterside (WS) toe. Siphon breaker in a 12-inch steel riser on the landside (LS) slope. Possible butterfly valve at the LS toe. 36-inch pipe authorized under Automatic Board Order (ABO) issued as Permit No.9302, 1974 - Barbara Lowe Elliott. [Additional Reference(s): DWR Levee Log, 1990. USACE Sacramento O&M Manual 127, June 1953, (Station 32+94)].

View of WS looking from levee crown

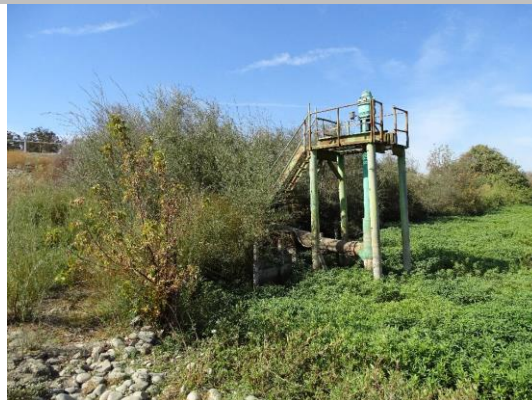
Photo 3 of 3 : UCIP_FA_2019_55685_82414.jpg

Comment Code						
Inspector Comment						
DS_ID:19361 FS_ID:55685 EP_NO: 9302 Repair Type: Urgent Crossing Status: Found UCIP Comments: 10/08/2019 Record has been updated from Non-Urgent to Urgent, excavation into WS slope and around pipe noted in USACE PI and UCIP 2013 inspection. Unable to confirm in 2019 whether excavation is still present on the WS slope due to dense vegetation on the WS. (O.Yakimov - DWR UCIP) 04/05/2013 Pipe exposed on WS slope in trench may need to be backfilled to prevent erosion under pipe. (W. Wylie - DWR UCIP) FIELD_STRUCT_DESC: 20-inch steel irrigation pipe through the levee, 8.8 feet below the crown. Pump on a steel pile structure at the waterside (WS) toe. Siphon breaker in a 12-inch steel riser on the landside (LS) slope. Possible butterfly valve at the LS toe. 36-inch pipe authorized under Automatic Board Order (ABO) issued as Permit No.9302, 1974 - Barbara Lowe Elliott). [Additional Reference(s): DWR Levee Log, 1990. USACE Sacramento O&M Manual 127, June 1953, (Station 32+94)]. FS Date: 10/8/2019

Pump on a pile platform in river channel

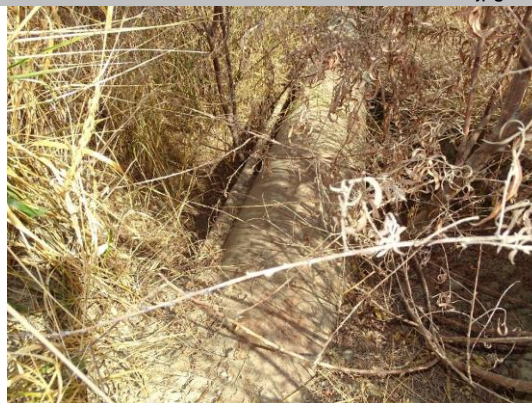
Photo 2 of 2 : UCIP_FA_2019_55686_82416.jpg

LM Start	0.87	Rating **	M	Issue No.	34	
LM End	0.87	Issue Type +	En	Location *		
Category	Supplemental			GPS Latitude/Longitude		
				Start	End	
Item	DRAFT DWR UCIP Field Study			38.727869 °	38.727869 °	
				-121.674875 °	-121.674875 °	
DWR ID	22967					
Comment Code						
Inspector Comment						
DS_ID:22967						
FS_ID:55686						
EP_NO: 9302						
Repair Type: Non-Urgent						
Crossing Status: Found						
UCIP Comments: 10/08/2019 No issues recorded during inspection (O.Yakimov - DWR UCIP)						
FIELD_STRUCT_DESC: 2.5-inch electrical conduit of an unknown material through the levee, 8.8 feet below the crown. Provides service for pump at the waterside (WS) toe. (Permit No. 9302, 1974 - Barbara Lowe Elliott). [Additional Reference(s): USACE Sacramento O&M Manual 127, June 1953].						
FS Date: 10/8/2019 3:10:34 PM

Electric conduit runs parallel toirrigation pipe along WS slope

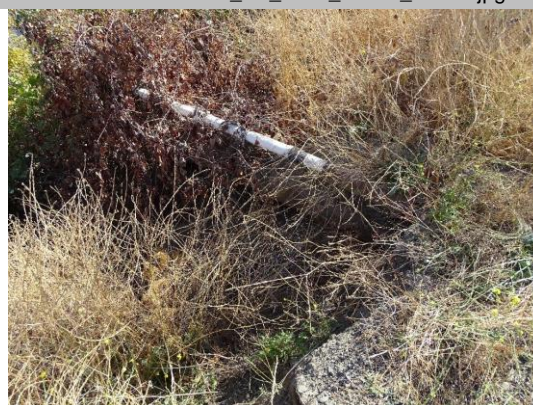
Photo 1 of 3 : UCIP_FA_2019_55687_82420.jpg

Comment Code					
Inspector Comment					
DS_ID:19362 FS_ID:55687 EP_NO: 9305 Repair Type: Urgent Crossing Status: Found UCIP Comments: 10/08/2019 WS slope has been excavated to expose pipe. 4-inch PVC is sleeved through 6-inch steel pipe at this location. Concrete standpipe on LS not found. (O.Yakimov - DWR UCIP)Slope on WS shoulder appears to be eroding at pipes exit from levee. 36-inch conc riser on LS is filled with mud. FIELD_STRUCT_DESC: 10-inch steel irrigation pipe through the levee, 5.8-feet below the crown. Pump at the waterward toe, pump motor on the waterward slope. Concrete headwall on the w/s slope. Concrete standpipe at the landward toe (Permit No. 9305-Bacchini) FS Date: 10/8/2019 4:06:00 PM

WS levee slope is excavated to expose pipes

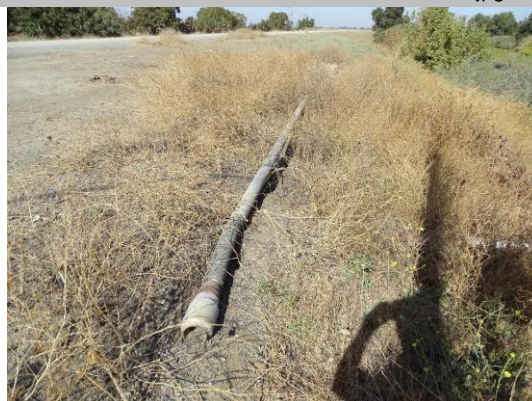
Photo 2 of 3 : UCIP_FA_2019_55687_82417.jpg

Comment Code						
Inspector Comment						
DS_ID:19362 FS_ID:55687 EP_NO: 9305 Repair Type: Urgent Crossing Status: Found UCIP Comments: 10/08/2019 WS slope has been excavated to expose pipe. 4-inch PVC is sleeved through 6-inch steel pipe at this location. Concrete standpipe on LS not found. (O.Yakimov - DWR UCIP)Slope on WS shoulder appears to be eroding at pipes exit from levee. 36-inch conc riser on LS is filled with mud. FIELD_STRUCT_DESC: 10-inch steel irrigation pipe through the levee, 5.8-feet below the crown. Pump at the waterward toe, pump motor on the waterward slope. Concrete headwall on the w/s slope. Concrete standpipe at the landward toe (Permit No. 9305-Bacchini) FS Date: 10/8/2019 4:06:00 PM

Disconnected 5-inch steel pipe on WS levee shoulder

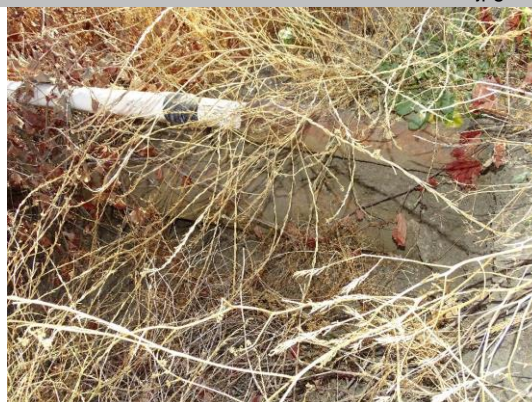
Photo 3 of 3 : UCIP_FA_2019_55687_83351.jpg

12-inch and 6-inch pipes visible

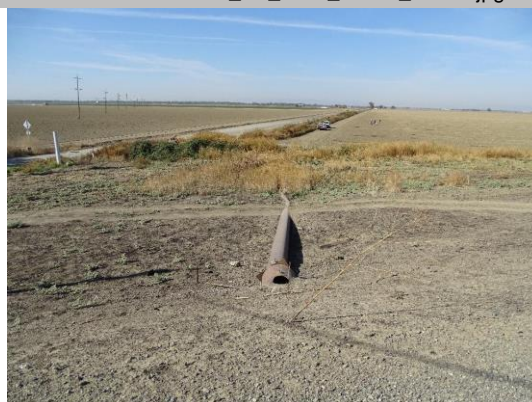
Photo 2 of 3 : UCIP_FA_2019_55692_82434.jpg

Comment Code						
Inspector Comment						
DS_ID:19363 FS_ID:55692 EP_NO: 939 Repair Type: Non-Urgent Crossing Status: Found UCIP Comments: 10/08/2019 No permit for sleeving 16-inch pipe found. Annular space between pipes not grouted. (O.Yakimov - DWR UCIP)04/05/2013 Space between 16-inch and 24-inch pipe should be grouted. There is no pump on stand at WS toe. FIELD_STRUCT_DESC: 24-inch steel irrigation pipe through the levee, 5.9 feet below the crown. 16-inch steel pipe sleeved through this pipe. No visible control valves. Pump on a pile structure in the stream. Siphon breaker on the landside (LS) slope. Pipe discharges into a concrete irrigation ditch off the LS toe. (Permit No. 939, 1943 - W. K. Lowe). [Additional Reference(s): DWR Levee Log, 1990. USACE Sacramento O&M Manual 127, June 1953, (Station 71+25)]. FS Date: 10/8/2019 8:04:40 AM

View of LS looking from levee crown

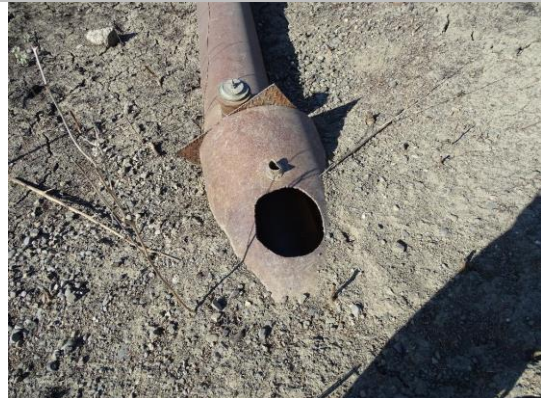
Photo 3 of 3 : UCIP_FA_2019_55692_82435.jpg

Comment Code						
Inspector Comment						
DS_ID:19363 FS_ID:55692 EP_NO: 939 Repair Type: Non-Urgent Crossing Status: Found UCIP Comments: 10/08/2019 No permit for sleeving 16-inch pipe found. Annular space between pipes not grouted. (O.Yakimov - DWR UCIP)04/05/2013 Space between 16-inch and 24-inch pipe should be grouted. There is no pump on stand at WS toe. FIELD_STRUCT_DESC: 24-inch steel irrigation pipe through the levee, 5.9 feet below the crown. 16-inch steel pipe sleeved through this pipe. No visible control valves. Pump on a pile structure in the stream. Siphon breaker on the landside (LS) slope. Pipe discharges into a concrete irrigation ditch off the LS toe. (Permit No. 939, 1943 - W. K. Lowe). [Additional Reference(s): DWR Levee Log, 1990. USACE Sacramento O&M Manual 127, June 1953, (Station 71+25)]. FS Date: 10/8/2019 8:04:40 AM

Siphon breaker and a cutout in 24-inch pipe at LS shoulder

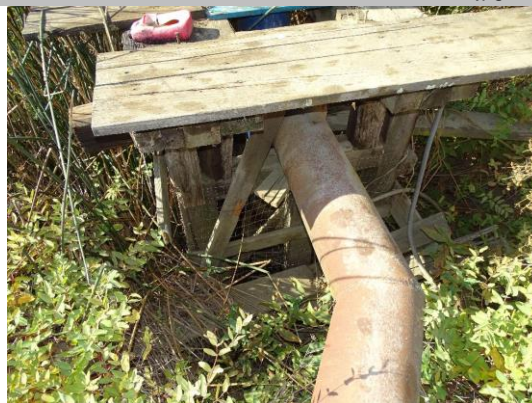
Photo 2 of 3 : UCIP_FA_2019_55698_82445.jpg

DS_ID:19364
FS_ID:55698
EP_NO: 9307
Repair Type: Non-Urgent
Crossing Status: Found
UCIP Comments: 10/08/2019 Siphon breaker not found on LS slope. Pipe outlet not found on WS. Work under permit 9307-1 not started. (O.Yakimov - DWR UCIP)04/05/2013 Siphon breaker on LS buried or broken off and missing.
FIELD_STRUCT_DESC: 1 of 2: 14-inch steel drainage pipe through the levee, 5.4 feet below the crown. Pump house on a pile structure at the landside (LS) toe. Siphon breaker on the LS slope. Service pole and anchor at the LS toe. (14-inch pipe [HLM 2.62] authorized under Automatic Board Order (ABO) issued as Permit No. 9307, 1974 - Azalene E. Lowe; a 12-foot section of an existing 14-inch pipe on LS replaced and name change under Permit No. 9307-1, 2016 - Ann Grube). [Additional Reference(s): DWR Levee Log, 1990. USACE Sacramento O&M Manual 127, June 1953, (Station 123+25)].
FS Date: 10/8/2019 8:30:25 AM

Pumping platform on pile structure

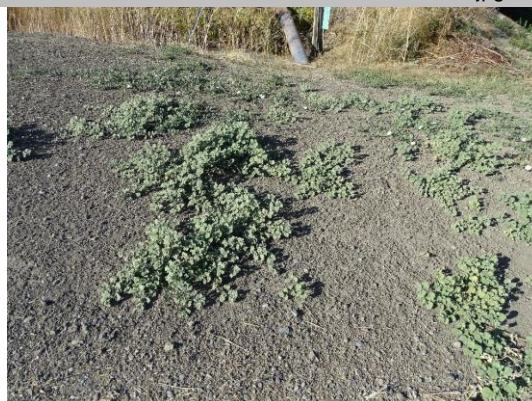
Photo 3 of 3 : UCIP_FA_2019_55698_82446.jpg

Comment Code						
Inspector Comment						
DS_ID:19364 FS_ID:55698 EP_NO: 9307 Repair Type: Non-Urgent Crossing Status: Found UCIP Comments: 10/08/2019 Siphon breaker not fornd on LS slope. Pipe outlet not forund on WS. Work under permit 9307-1 not started. (O.Yakimov - DWR UCIP)04/05/2013 Siphon breaker on LS burried or broken off and missing. FIELD_STRUCT_DESC: 1 of 2: 14-inch steel drainage pipe through the levee, 5.4 feet below the crown. Pump house on a pile structure at the landside (LS) toe. Siphon breaker on the LS slope. Service pole and anchor at the LS toe. (14-inch pipe [HLM 2.62] authorized under Automatic Board Order (ABO) issued as Permit No. 9307, 1974 - Azalene E. Lowe; a 12-foot section of an existing 14-inch pipe on LS replaced and name change under Permit No. 9307-1, 2016 - Ann Grube). [Additional Reference(s): DWR Levee Log, 1990. USACE Sacramento O&M Manual 127, June 1953, (Station 123+25)]. FS Date: 10/8/2019 8:30:25 AM

Not found siphon breaker on LS slope

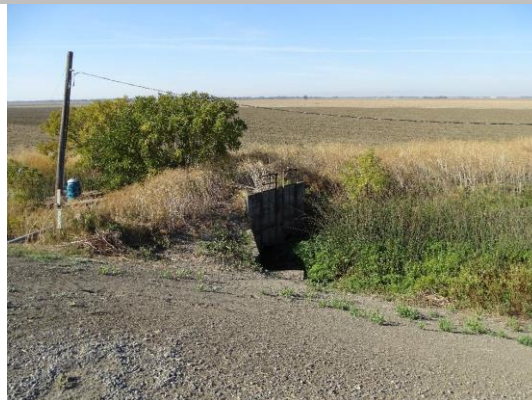
Photo 1 of 3 : UCIP_FA_2019_55708_82487.jpg

Comment Code						
Inspector Comment						
DS_ID:19391 FS_ID:55708 EP_NO: 9307 Repair Type: Non-Urgent Crossing Status: Found UCIP Comments: 10/08/2019 Slide gate actuator is not accessible without use of equipment. (O.Yakimov - DWR UCIP)04/05/2013 Walkway to actuator slide gate is missing. No method of actuating slide gate. FIELD_STRUCT_DESC: 2 of 2: 48-inch by 48-inch reinforced concrete box drainage culvert through the levee, 23 feet below the crown. Walkway to slide gate on the waterside (WS) end. Concrete headwalls on both ends. Service pole and anchor at the landside (LS) toe. Concrete headwalls on both ends. (four foot by four foot culvert [HLM 2.62] authorized under Automatic Board Order (ABO) issued as Permit No. 9307, 1974 - Azalene E. Lowe). [Additional Reference(s): DWR Levee Log, 1990. USACE Sacramento O&M Manual 127, June 1953, (Station 123+55.5)]. FS Date: 10/8/2019 10:14:53 AM

View of LS looking from levee crown

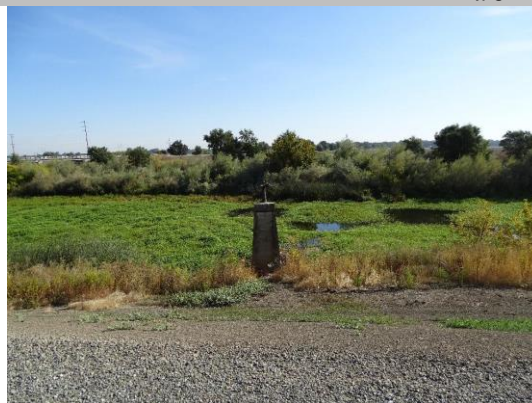
Photo 2 of 3 : UCIP_FA_2019_55708_82488.jpg

View of WS looking from levee crown

Comment Code						
Inspector Comment						
DS_ID:19391 FS_ID:55708 EP_NO: 9307 Repair Type: Non-Urgent Crossing Status: Found UCIP Comments: 10/08/2019 Slide gate actuator is not accessible without use of equipment. (O.Yakimov - DWR UCIP)04/05/2013 Walkway to actuater slide gate is missing. No method of actuating slide gate. FIELD_STRUCT_DESC: 2 of 2: 48-inch by 48-inch reinforced concrete box drainage culvert through the levee, 23 feet below the crown. Walkway to slide gate on the waterside (WS) end. Concrete headwalls on both ends. Service pole and anchor at the landside (LS) toe. Concrete headwalls on both ends. (four foot by four foot culvert [HLM 2.62] authorized under Automatic Board Order (ABO) issued as Permit No. 9307, 1974 - Azalene E. Lowe). [Additional Reference(s): DWR Levee Log, 1990. USACE Sacramento O&M Manual 127, June 1953, (Station 123+55.5)]. FS Date: 10/8/2019 10:14:53 AM

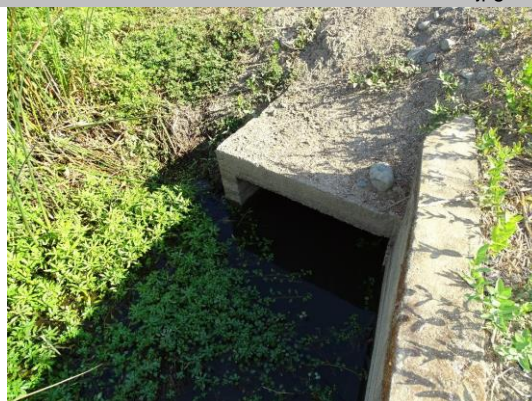
Photo 3 of 3 : UCIP_FA_2019_55708_82486.jpg

Inlet of 48 x 48 inch concrete culvert. View from LS

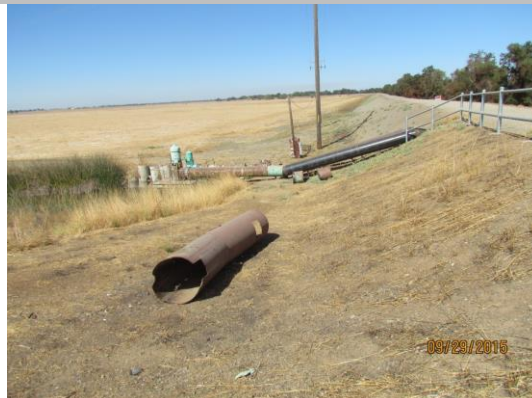
Photo 1 of 2 : FA_2019_NA0008_256_18_20190829_00003.jpg

LM Start	2.70	Rating **	M	Issue No.	18
LM End	2.70	Issue Type +	En	Location *	LS
Category	Earthen Levee			GPS Latitude/Longitude	
				Start	End
Item	Encroachments			38.748837 °	38.748837 °
				-121.694823 °	-121.694823 °
DWR ID	DWR_NA0008_01_f_2015_18				
Comment Code					
DE : Debris					
Inspector Comment					
A portion of the pipe seems to have been replaced and the abandoned pipe is left at the toe of the landward side of the levee.

View of the abandoned pipe at the toe of levee on the landward side.
Fall 2015.

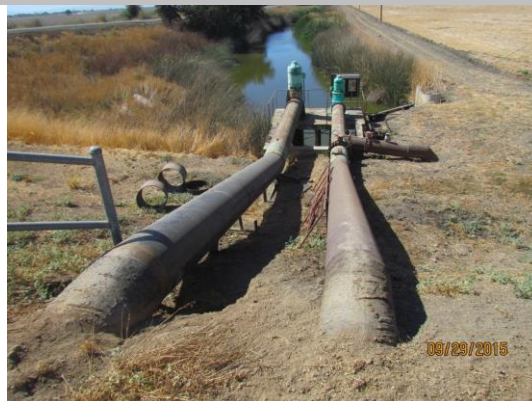
Photo 2 of 2 : FA_2019_NA0008_256_18_20190829_00004.jpg

The dark portion on the left pipe seems to have been replaced with a new pipe. Fall 2015.

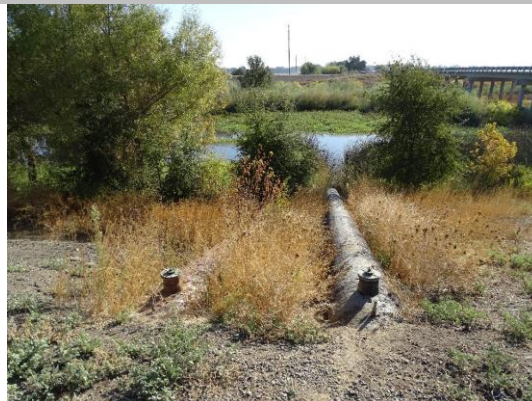
Photo 2 of 3 : UCIP_FA_2019_55721_82554.jpg

Comment Code						
Inspector Comment						
DS_ID:19394 FS_ID:55721 EP_NO: 8752 Repair Type: Non-Urgent Crossing Status: Found UCIP Comments: 10/08/2019 Top of concrete C-shaped headwall on LS berm is tilting towards the levee, cracks in concrete observed. Erosion around the headwall off LS levee toe. Although pipes don't seem to be leaning on the headwall, a sloughing may occur if headwall fails. Recommend closer observation of the crossing. (O.Yakimov - DWR UCIP) FIELD_STRUCT_DESC: 1 of 2: 30-inch asphalt coated steel drainage pipe through the levee, 3 feet below the crown. Siphon breaker on pipe on the waterside (WS) shoulder. Pump on a steel pile structure at the landside (LS) toe. (Permit No. 8752, 1973 - Reclamation District No. 730). Some design drawings available in permit. [Additional Reference(s): DWR Levee Log, 1990]. FS Date: 10/8/2019 2:05:13 PM

View of WS looking from levee crown

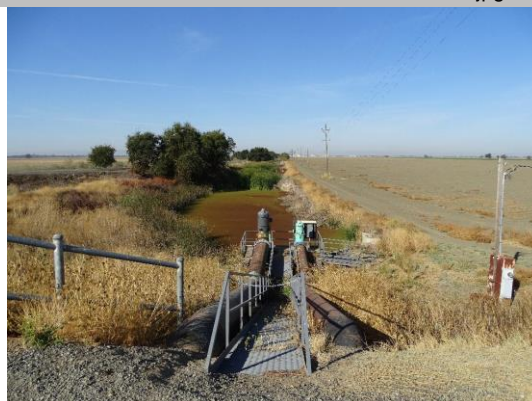
Photo 3 of 3 : UCIP_FA_2019_55721_82555.jpg

Comment Code						
Inspector Comment						
DS_ID:19394 FS_ID:55721 EP_NO: 8752 Repair Type: Non-Urgent Crossing Status: Found UCIP Comments: 10/08/2019 Top of concrete C-shaped headwall on LS berm is tilting towards the levee, cracks in concrete observed. Erosion around the headwall off LS levee toe. Although pipes don't seem to be leaning on the headwall, a sloughing may occur if headwall fails. Recommend closer observation of the crossing. (O.Yakimov - DWR UCIP) FIELD_STRUCT_DESC: 1 of 2: 30-inch asphalt coated steel drainage pipe through the levee, 3 feet below the crown. Siphon breaker on pipe on the waterside (WS) shoulder. Pump on a steel pile structure at the landside (LS) toe. (Permit No. 8752, 1973 - Reclamation District No. 730). Some design drawings available in permit. [Additional Reference(s): DWR Levee Log, 1990]. FS Date: 10/8/2019 2:05:13 PM

View of LS looking from levee crown

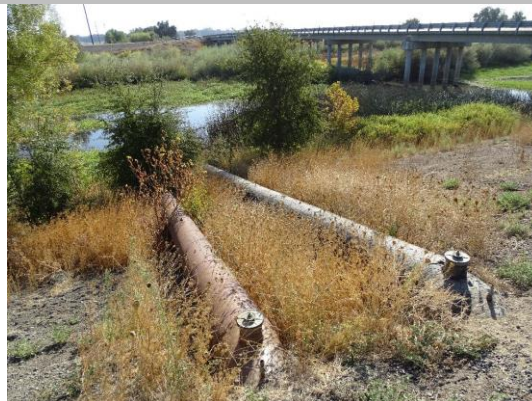
Photo 2 of 3 : UCIP_FA_2019_55722_82563.jpg

Comment Code					
Inspector Comment					
DS_ID:19395 FS_ID:55722 EP_NO: 8752 Repair Type: Non-Urgent Crossing Status: Found UCIP Comments: 10/08/2019 Top of concrete C-shaped headwall on LS berm is tilting towards the levee, cracks in concrete observed. Erosion around the headwall off LS levee toe. Although pipes don't seem to be leaning on the headwall, a sloughing may occur if headwall fails. Recommend closer observation of the crossing. (O.Yakimov - DWR UCIP) FIELD_STRUCT_DESC: 2 of 2: 24-inch steel drainage pipe through the levee, 3 feet below the crown. Siphon breaker on pipe on the waterside (WS) shoulder with a pump on a steel pile structure at the landside (LS) toe. Butterfly shutoff valve at the LS toe. (Permit No. 8752, 1973 - Reclamation District No. 730). Some design drawings available. [Additional Reference(s): DWR Levee Log, 1990]. FS Date: 10/8/2019 2:17:18 PM

View of WS looking from levee crown

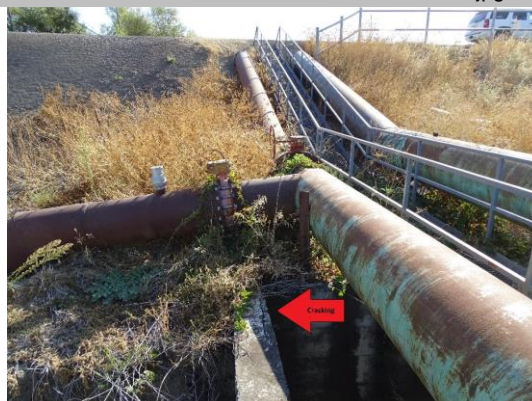
Photo 3 of 3 : UCIP_FA_2019_55722_82560.jpg

LS levee slope and pipe

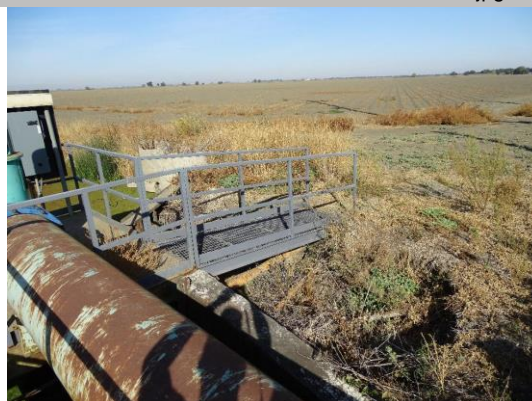
Photo 2 of 3 : UCIP_FA_2019_55724_82565.jpg

Erosion around headwall on WS

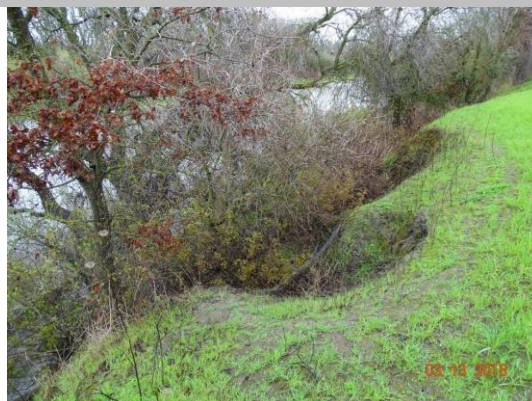
Photo 1 of 2 : FA_2019_NA0008_256_20_20190829_00005.jpg

View of erosion on the waterside slope. Spring 2018.

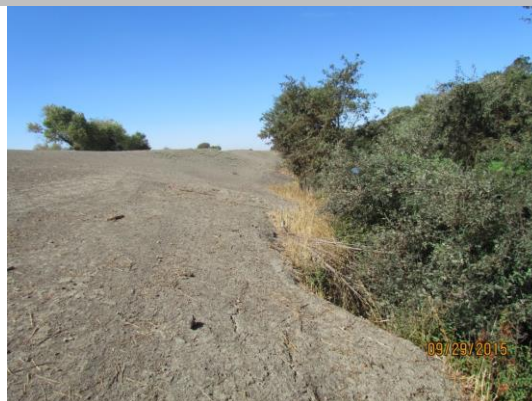
Photo 2 of 2 : FA_2019_NA0008_256_20_20190829_00006.jpg

View of the erosion on the waterward side of the levee looking upstream.
Fall 2015.

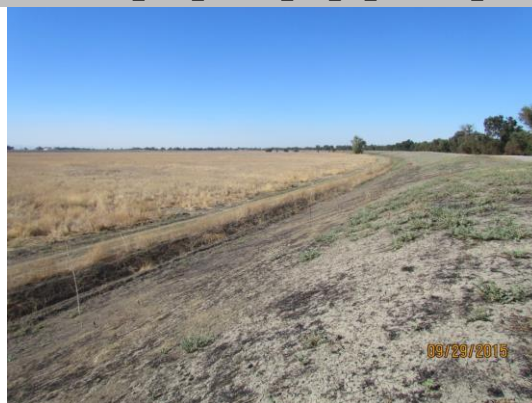
Photo 1 of 1 : FA_2019_NA0008_256_22_20190829_00007.jpg

View of the ditch on the landward side of the levee looking upstream.
Fall 2015.

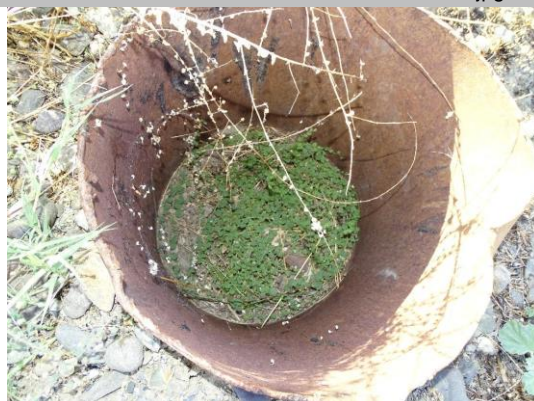
Photo 3 of 3 : UCIP_FA_2019_55745_82654.jpg

Siphon breaker in damaged 16-inch steel riser on LS shoulder

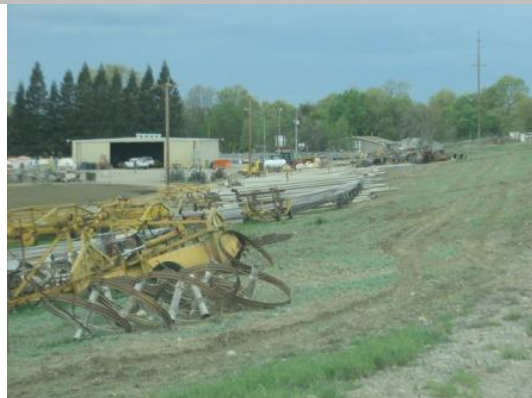
Photo 2 of 2 : FA_2019_NA0008_256_7_20190829_00002.jpg

A view of the equipment on the levee slope. Spring 2014

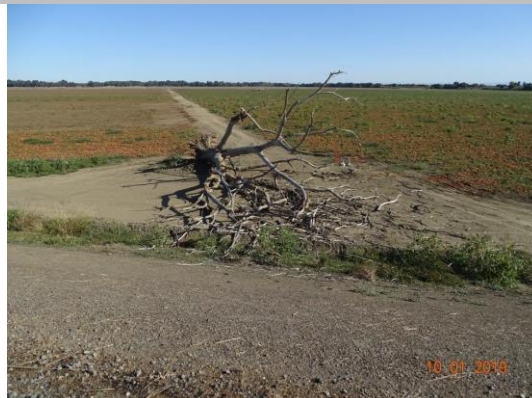
Photo 1 of 1 : FA_2019_NA0008_257_20_20191001_00030.jpg

View of the fallen tree at the landside toe. Fall 2019.

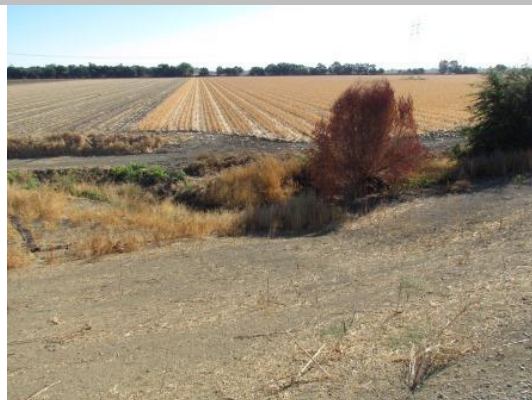
Photo 1 of 1 : FA_2019_NA0008_257_22_20190829_00008.jpg

View of a ditch near landside toe. Fall 2016.

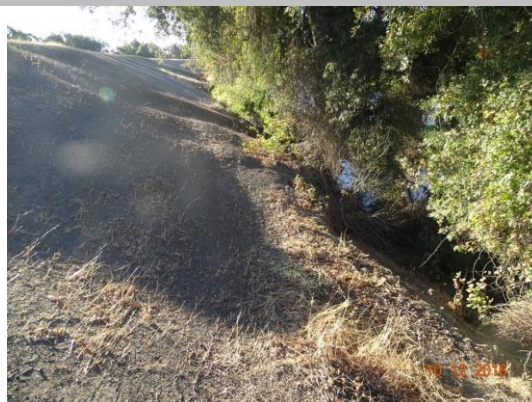
Photo 1 of 2 : FA_2019_NA0008_257_9_20190829_00003.jpg

View of the erosion on the waterside slope. Fall 2018.

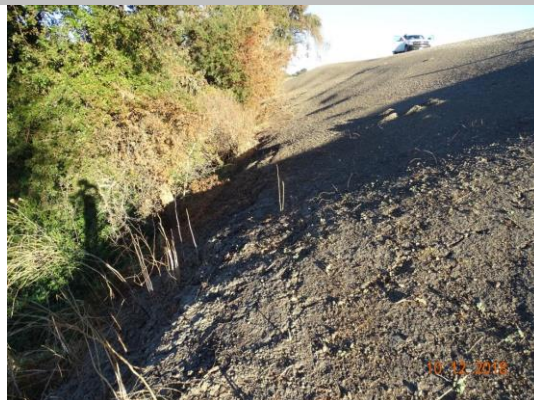
Photo 1 of 2 : FA_2019_NA0008_257_14_20190829_00005.jpg

View of erosion on the waterside slope. Fall 2018.

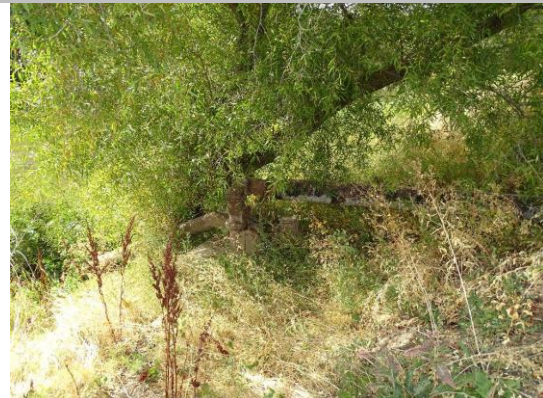
Photo 3 of 3 : UCIP_FA_2019_55779_82814.jpg

Abandoned pump on WS slope
